LINCOLN, NEW MEXICO

A Plan for Preservation and Growth

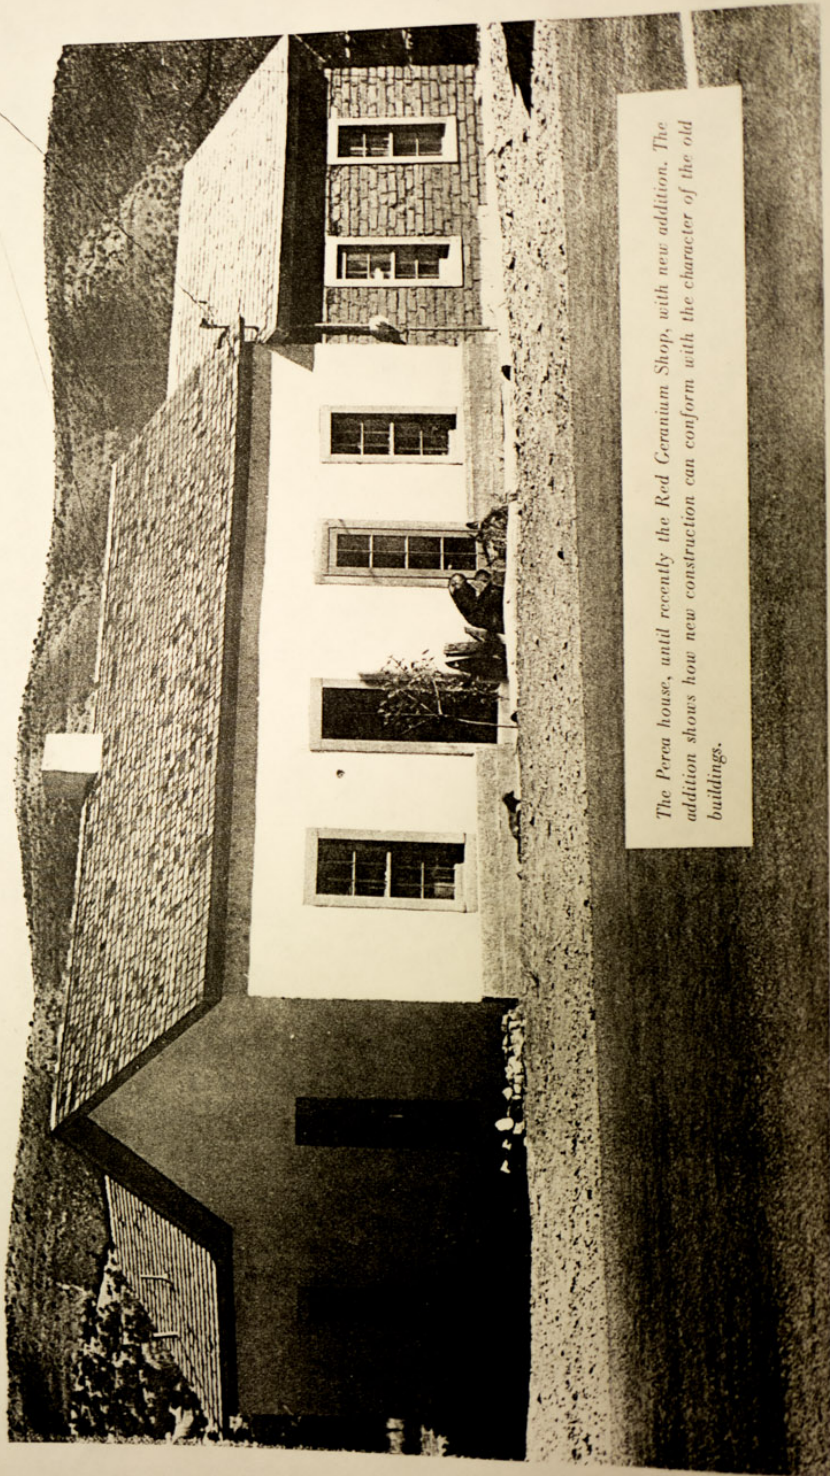
*The Pera house, until recently the Red Ceranium Shop, with new addition. The addition shows how new construction can conform with the character of the old buildings.*

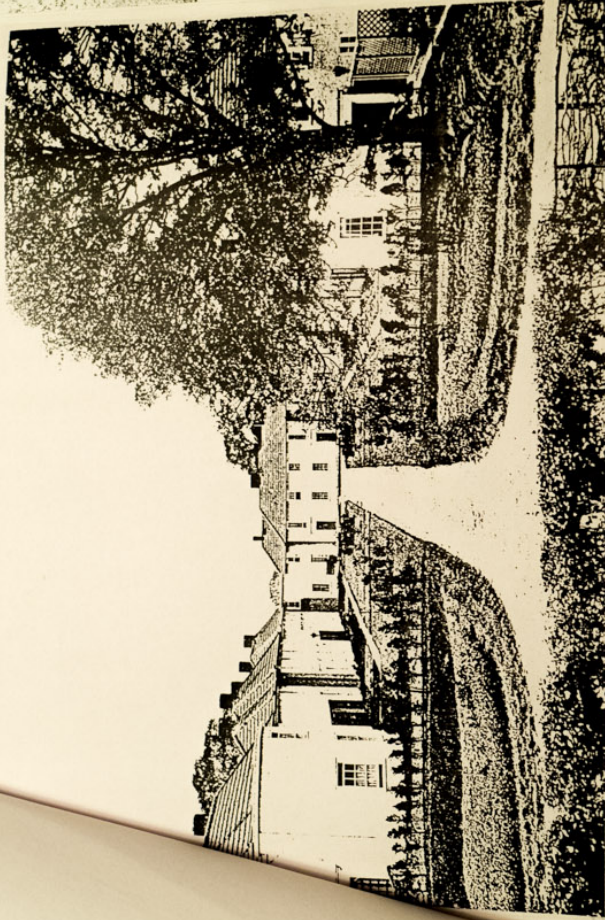
Photograph 1. (See Plate 41.) The close was kept short with an open end to the road, so as to allow the general design of this close to form part of the road picture.

Example from Welwyn Garden City by Louis De Soissons, 1927

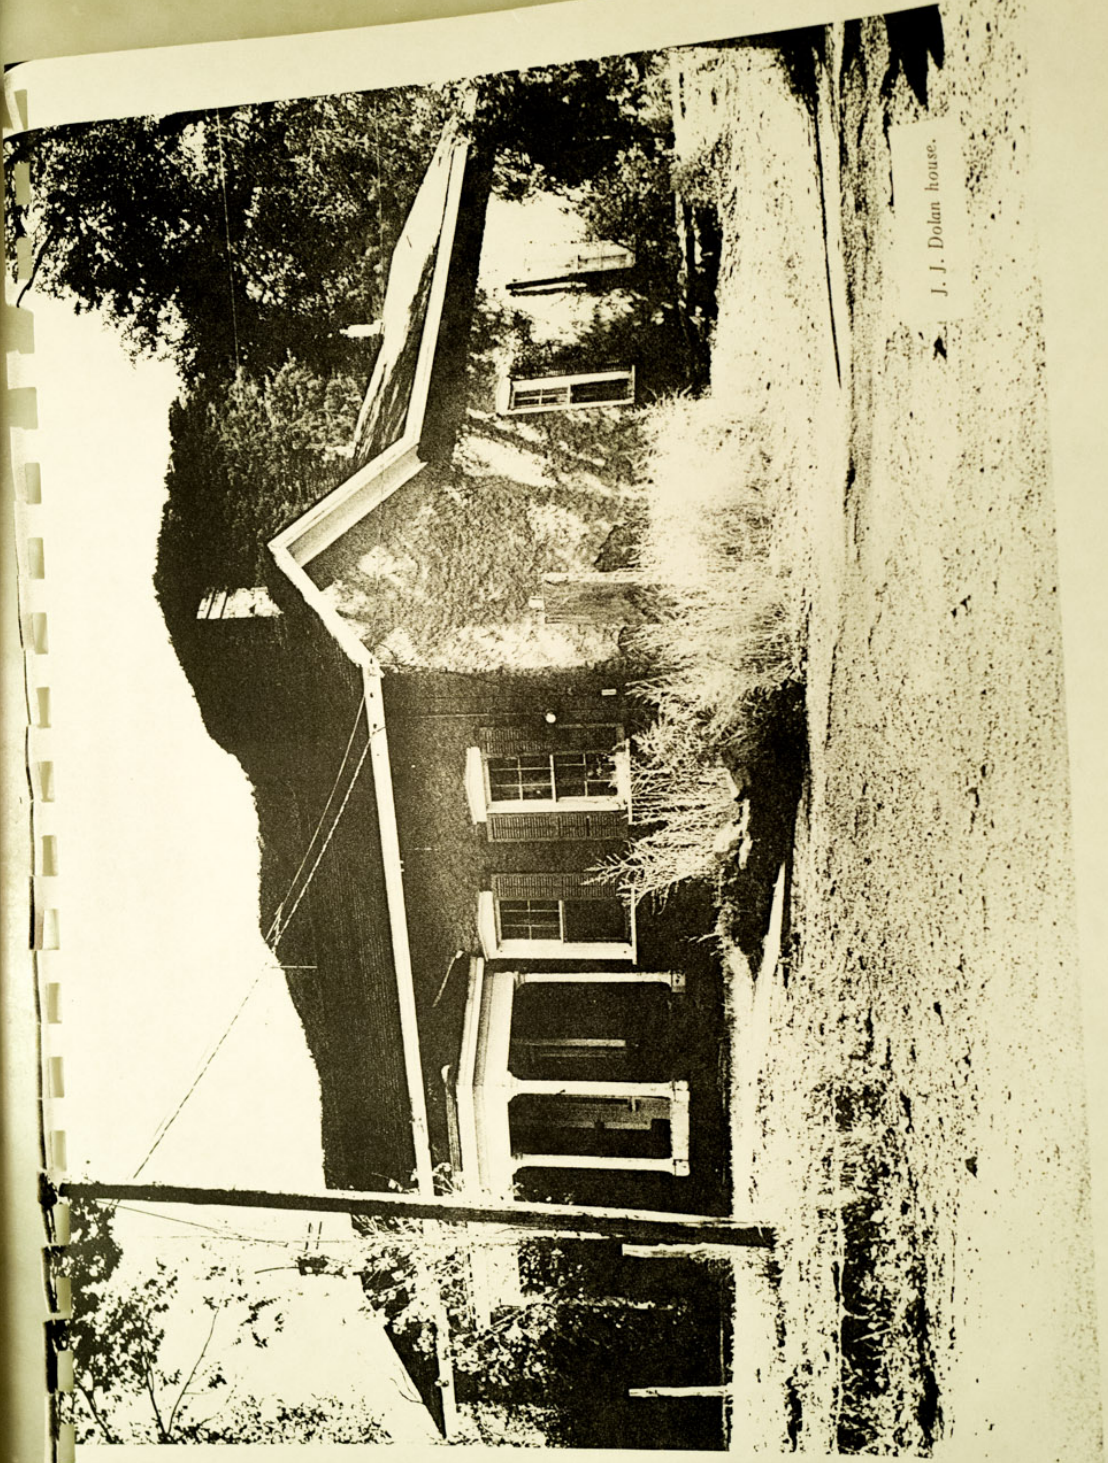
No. 11 J. J. DOLAN HOUSE

J. J. Dolan house.

The Dolan House, formerly the Bonito Inn, is now a residence. It is in excellent condition and should not be altered.

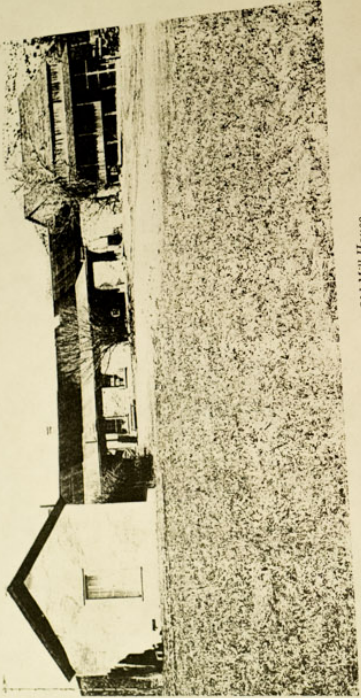
**No. 43 OLD MILL HOUSE.**

*View of Ellis House and Old Mill House.*

This mill house was used as a nurses' quarters at the turn of the century, when the Ellis Store and dwelling was operated as a T.B. sanitarium by Dr. Laws.

This is a very rare example of half-timber construction with adobe fillers. The half-timber type of construction came to northern Europe and into England from the Balkans. There are very few authentic examples in North America. The application of the style to a flour mill was logical, as it affords a very strong frame to absorb the heavy vibrations of the mill machinery. This building, while not of the 1878-81 period, should be restored for its rare architectural style.

The building is of half-timber construction up through the first floor, with a wood frame second floor that was perhaps added when the place was converted into a nurses' quarters. The wide porch on the south and east was also, undoubtedly, added at that time.

A program for the restoration and use of this building should be worked out with the present owners and the Historical Commission.

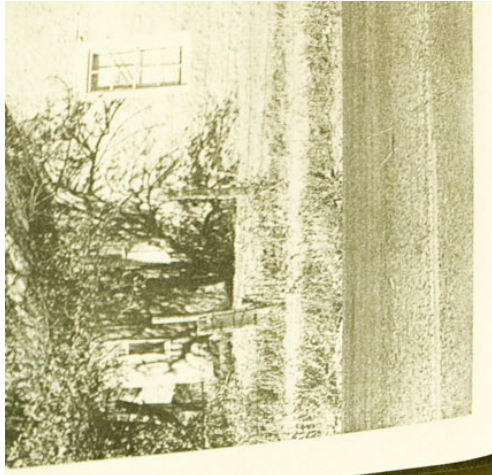
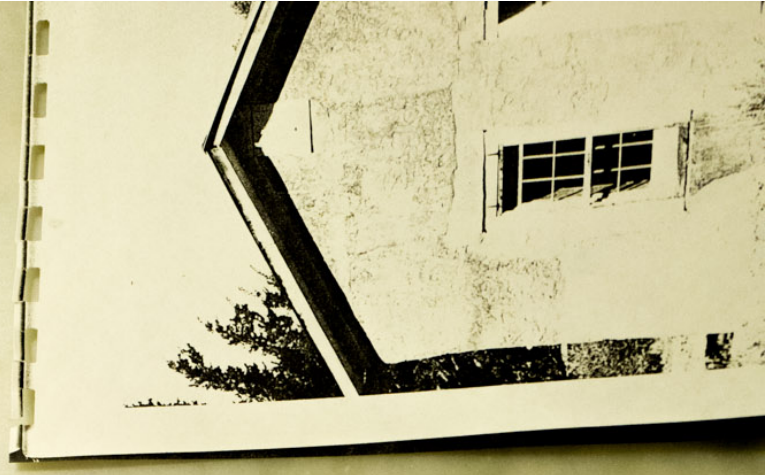
**No. 9 JAMES RAMSEY HOUSE**

Doors: Windows: In fair to good condition.

This building is a classic example of the later Lincoln style, and every effort should be made for its restoration with no alteration of plan, elevation or doors and windows.

**Foundation:** Rock. The southeast corner of the west wing is in very poor condition and should be repaired immediately.

**Walls:** Adobe. Stuccoed over with lime-sand mixture; in need of repair.

**Roof:** Wood shingle. Needs immediate recovering with wood shingles.

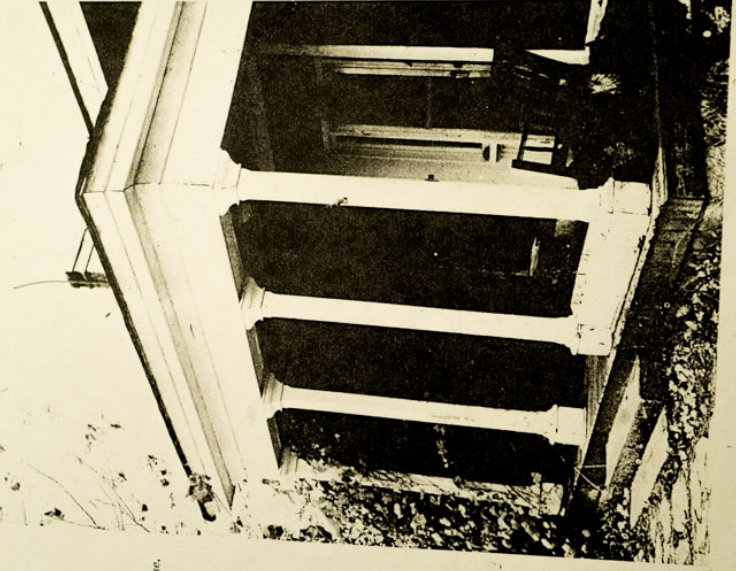
*Porch of Dolan House.*

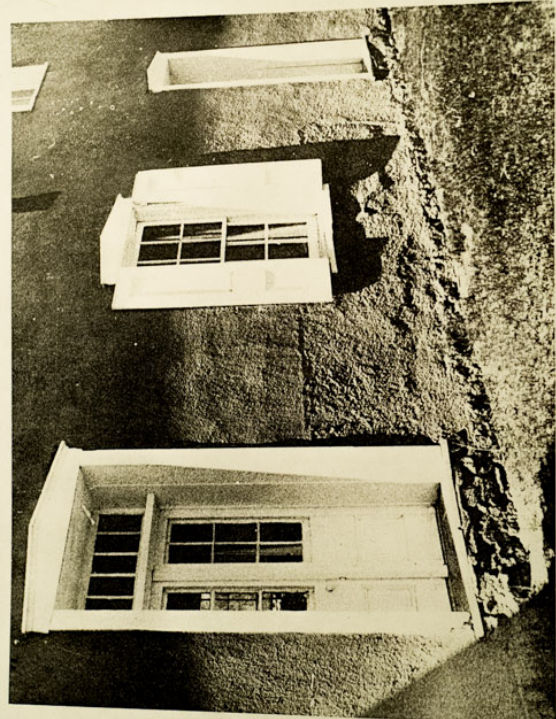
**No. 1 MURPHY-DOLAN STORE.** Referred to as the old Lincoln County Courthouse.

This building is owned by the old Lincoln Memorial Commission. It has been restored and is in good condition. There perhaps should be, at some time in the future, a rebuilding of the front two-story porch to restore it to the condition shown in the earliest known photograph, which exhibits two flanking stairways.

*Murphy-Dolan Store. Door and window detail, showing shutters and trim.*

At a time when the interpretive museum material can be moved to the schoolhouse east of the Murphy-Dolan Store, the interior should be furnished with items that were stocked at the time it was operated as a store in the 1870-80's. The courtroom on the second floor should be furnished as it was when used as a court.

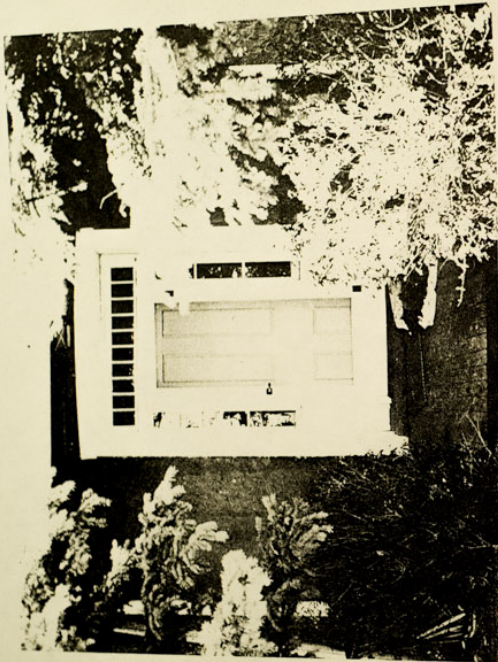
*Brent House; detail showing typical Lincoln door with sidelites and transom.*

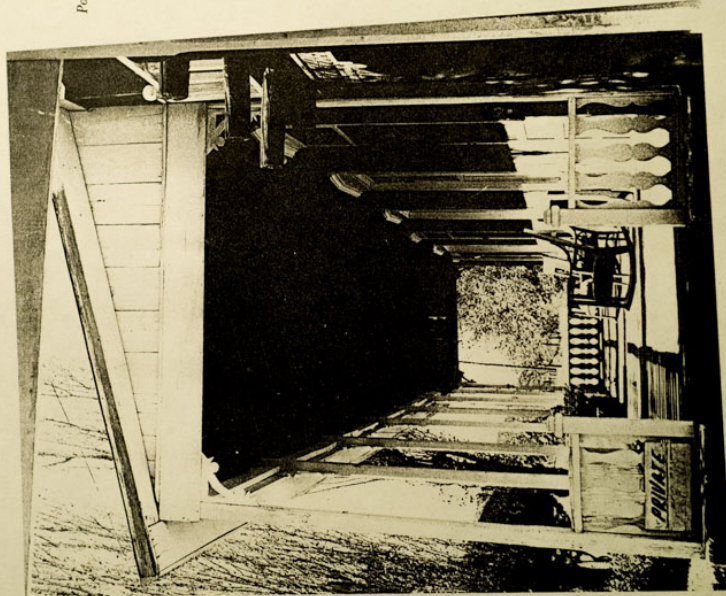
*Porch of Maes House.*

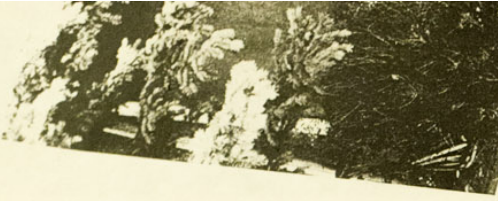
*Brent House; detail*

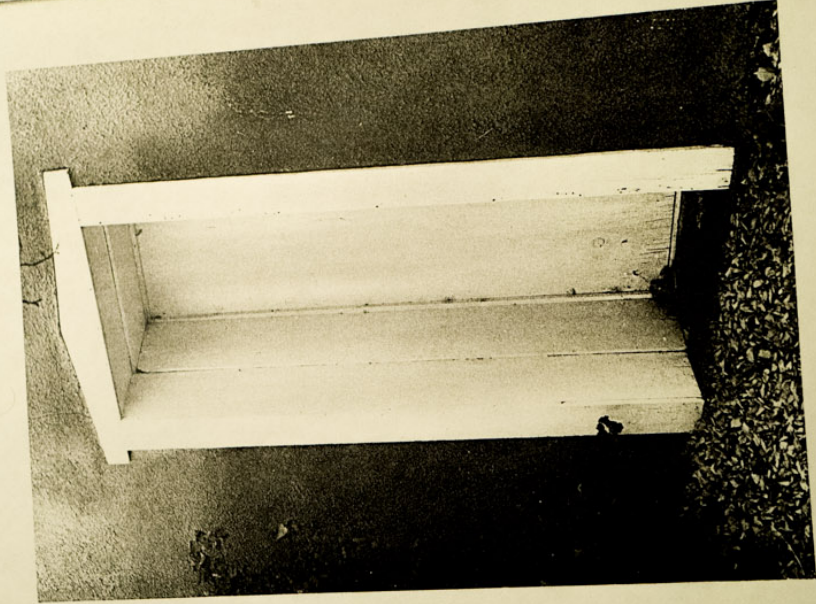
**No. 14 EARLIEST COURTHOUSE.** Later a convent.

This is shown as courtroom No. 41 on Mullin's map of 1878 and as Community Hall in 1881. This building is owned by the State of New Mexico and has recently been restored.

*Door: detail of first courthouse.*
